PATAPSCO RIVER BASIN STUDY

Prepared By:
Regional Planning Council
U.S.D.A. Soil Conservation Service
March 1980

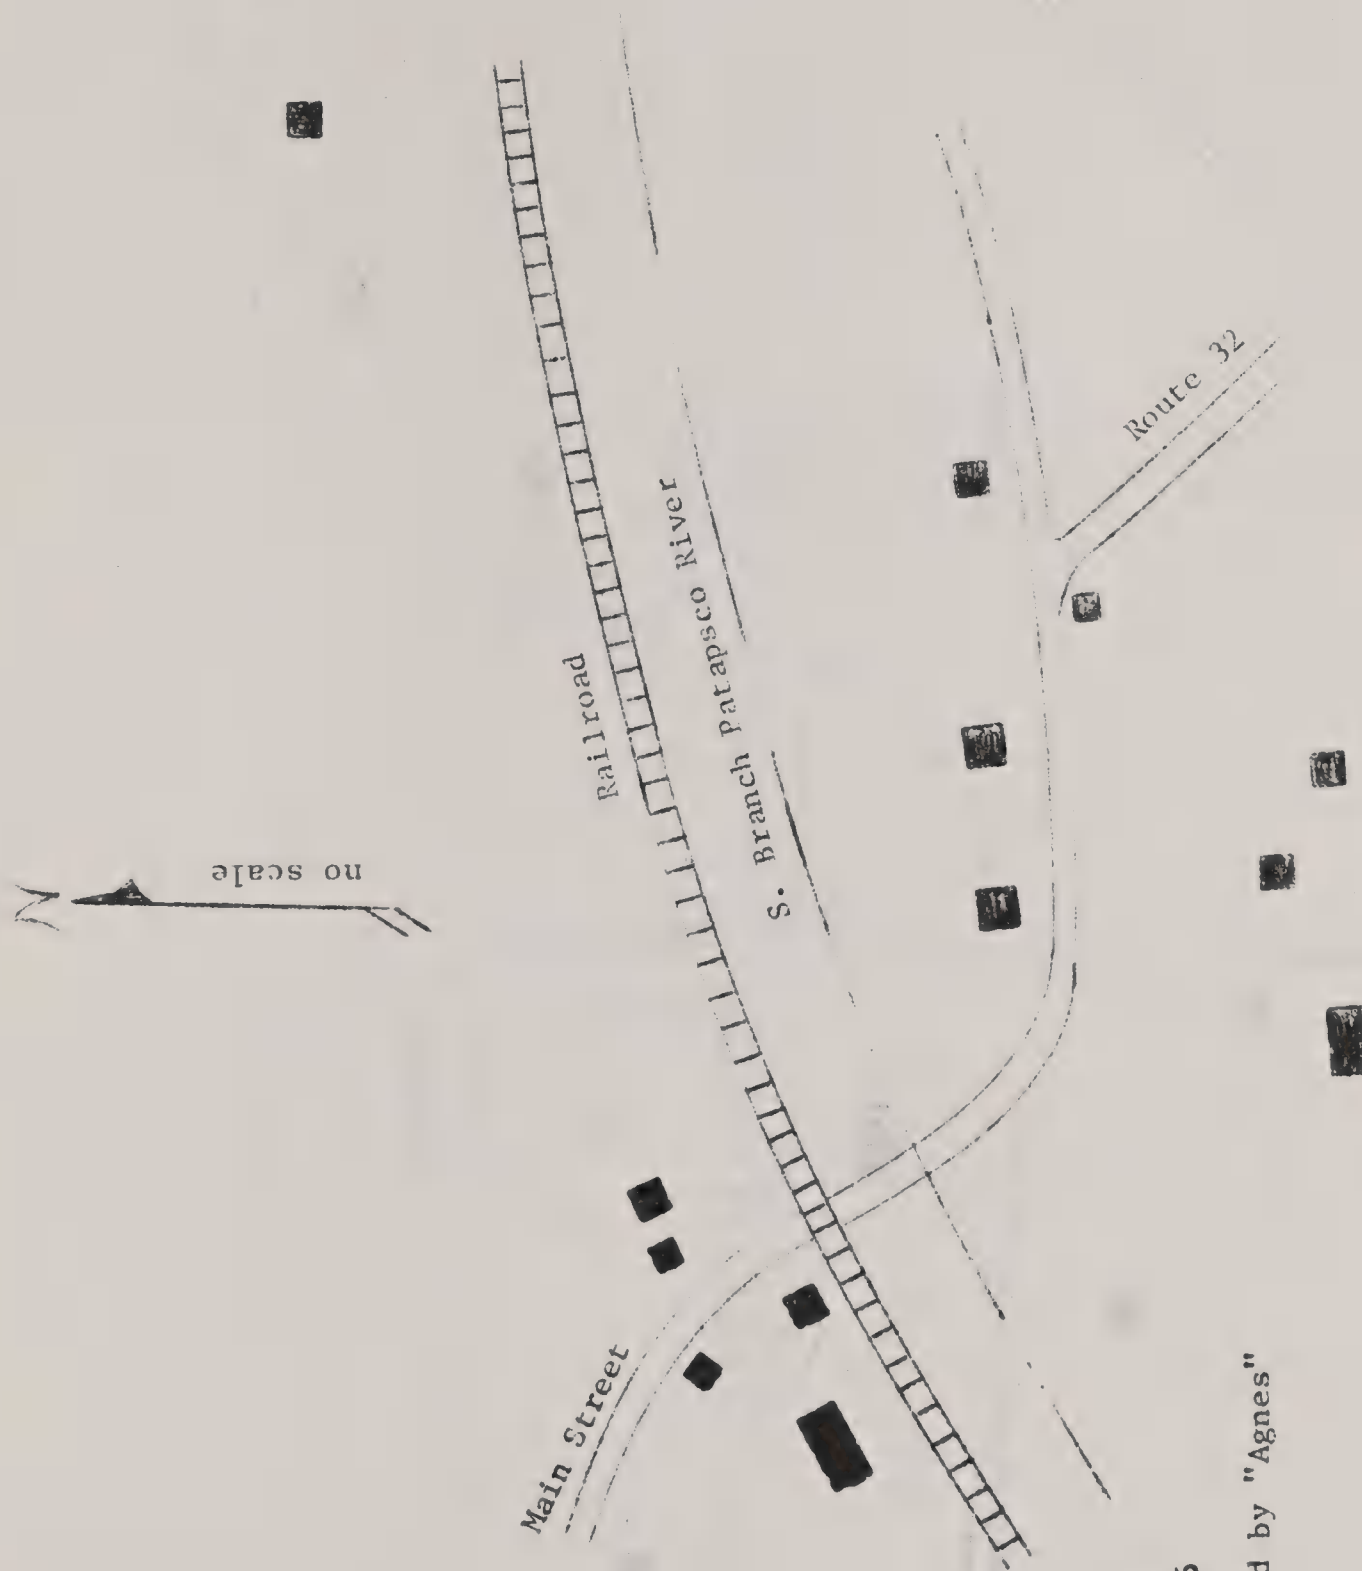
FIGURE 6
 Structures Flooded by "Agnes"
 Patapsco River
 PR-22 Sykesville

Sykesville (PR-22), had more commercial structures damaged than any other area along the South Branch. (See Figure 6.) Six businesses and two homes were flooded. Two taverns on the Howard County side of the river had from five to eight feet of water around them. The other businesses and homes had less of a problem with damage confined to basements and low levels on the first floor. In Gaither (PR-23), five houses were flooded with first floor depths rising to nearly six feet in three of them.

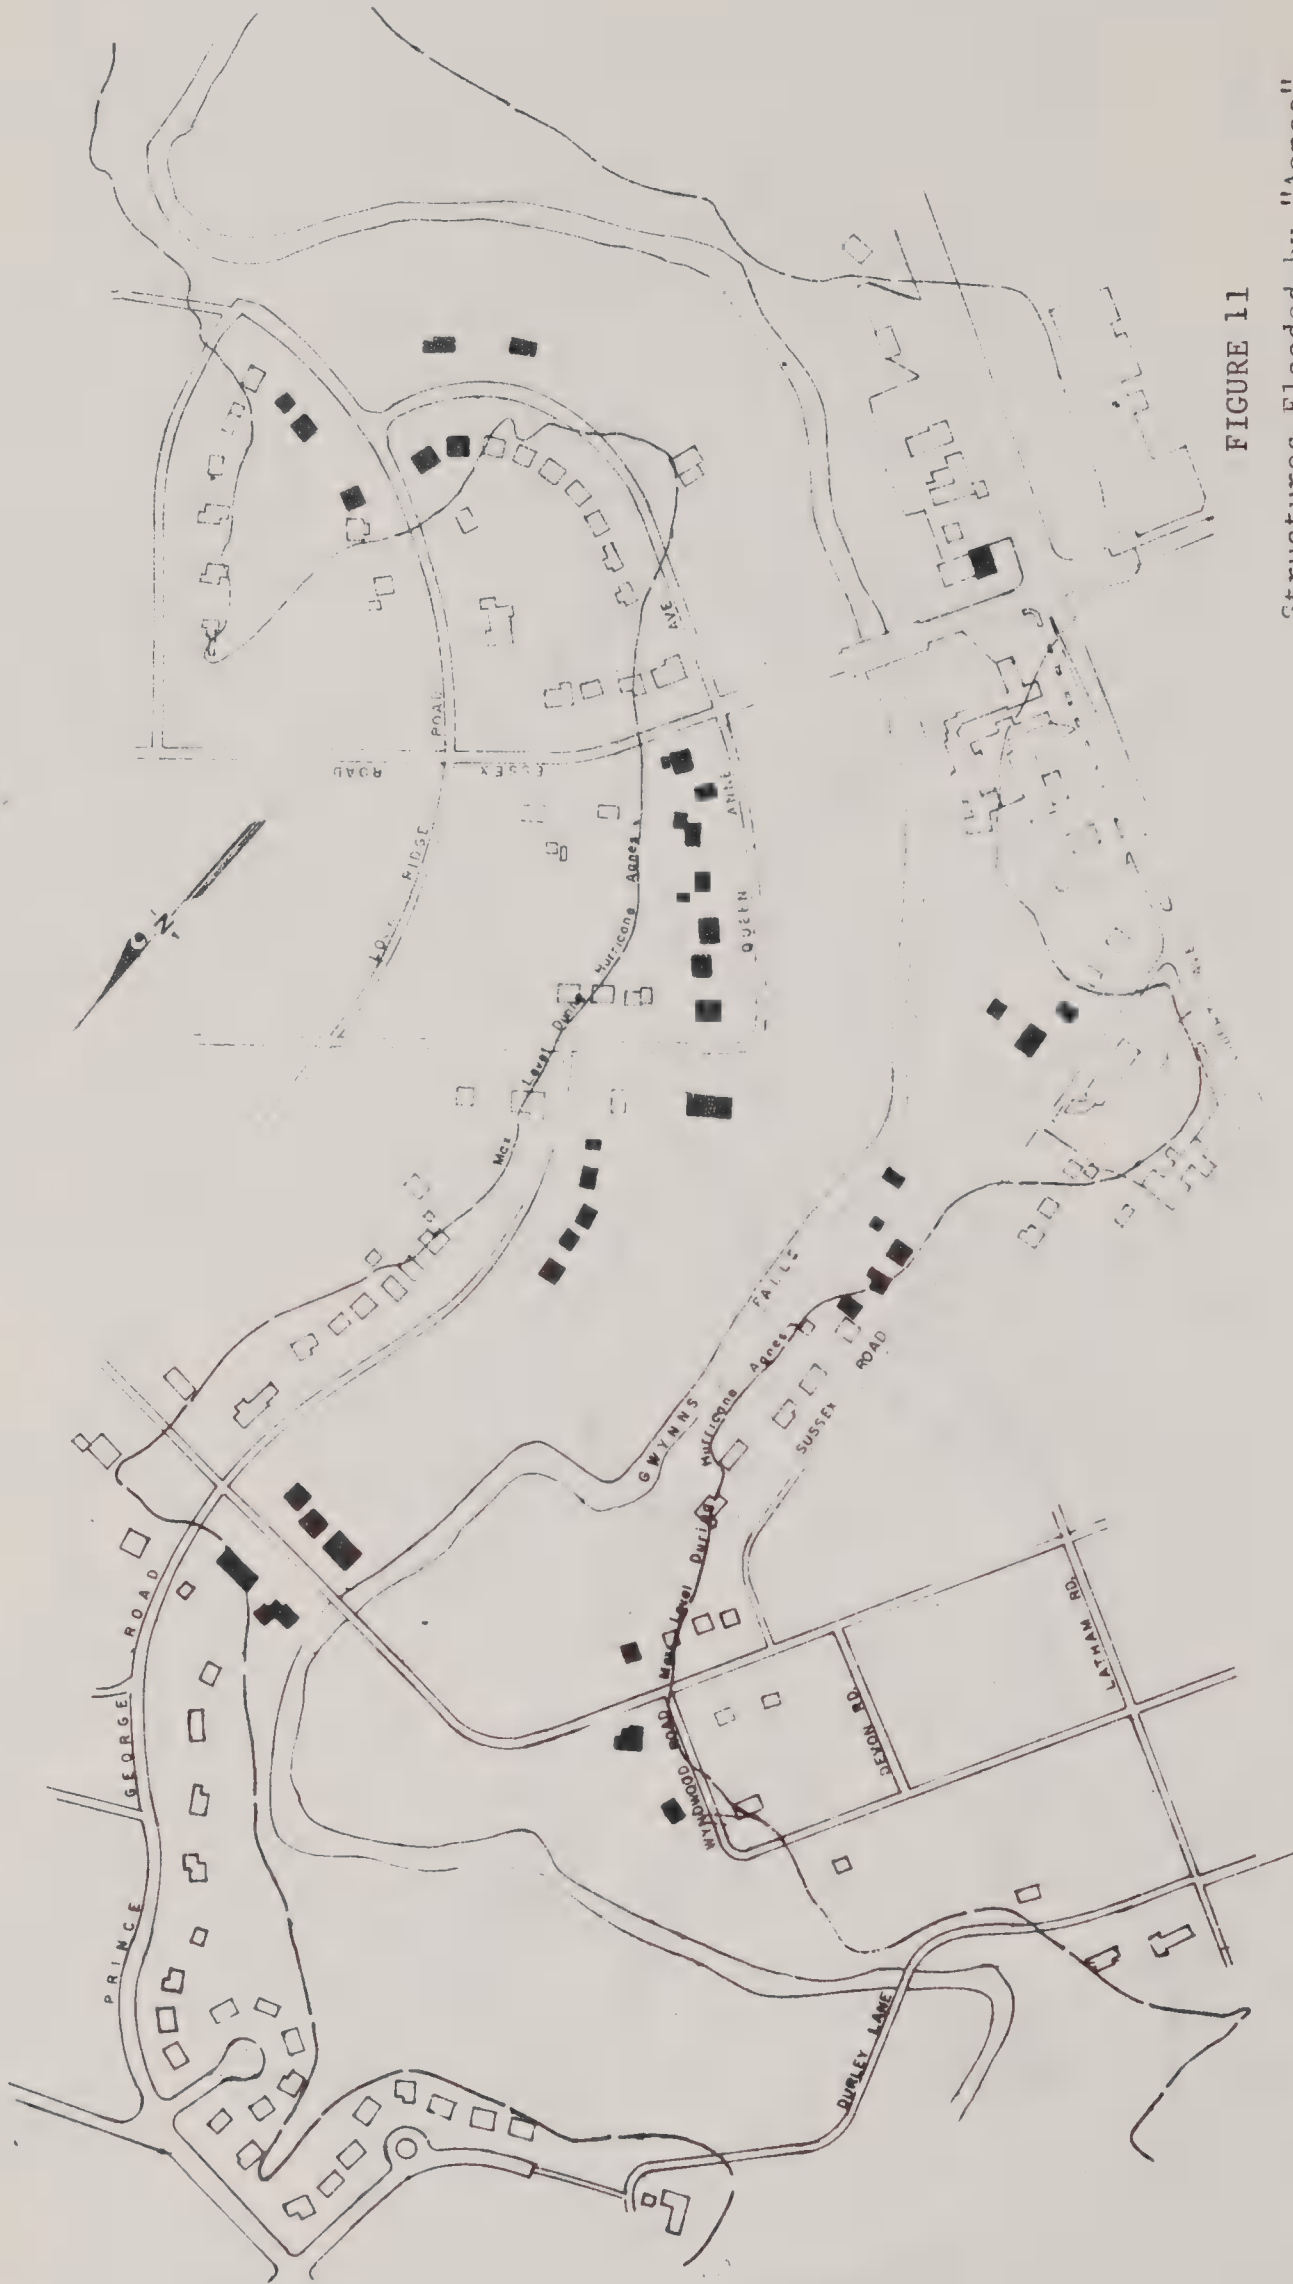
FIGURE 11
Structures Flooded by "Agnes"
Gwynns Falls
GF-11 Villa Nova

Note: Shaded structures are to be
acquired as part of Baltimore
County's acquisition program

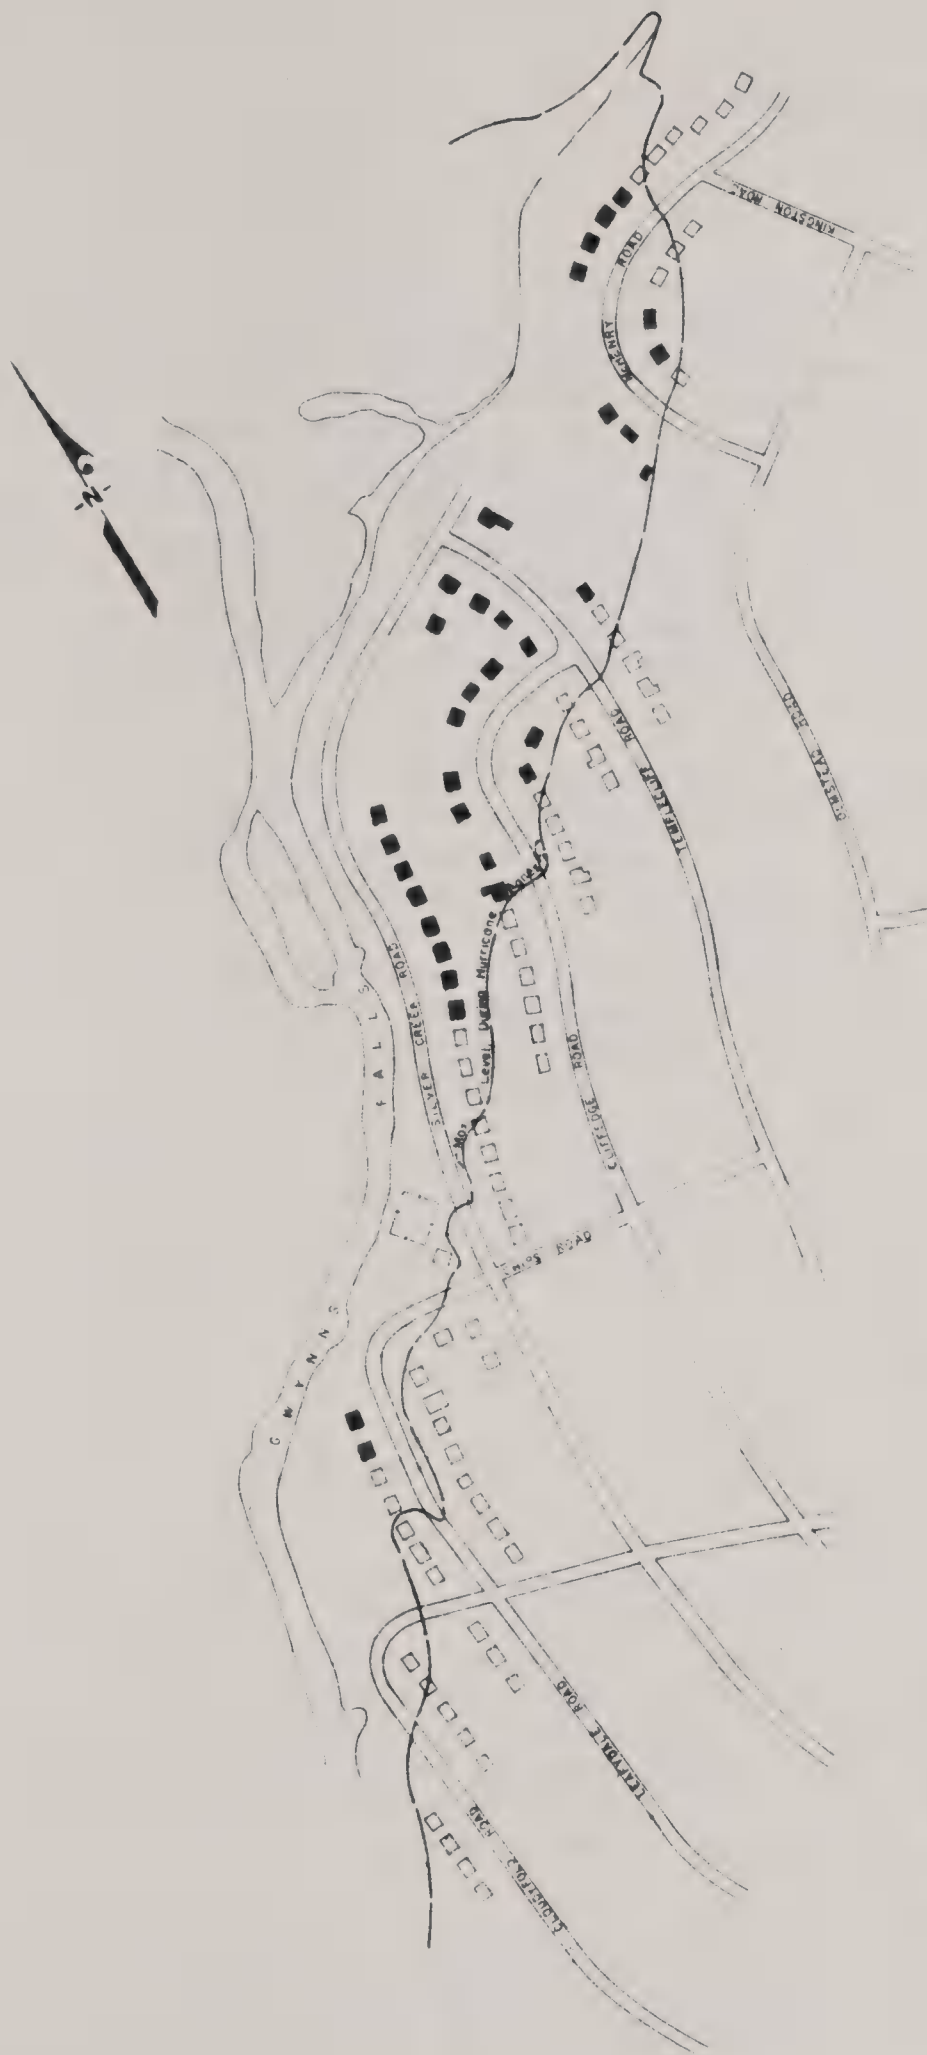
Note: Shaded structures are to be
acquired as part of Baltimore
County's acquisition program

FIGURE 12
Structures Flooded by "Agnes"
Gwynns Falls
GF-12 Silver creek Park
